SOUTHERN MAINE COASTAL BASIN  
YORK, MAINE

BOULTER DAM  
ME 00194

PHASE I INSPECTION REPORT  
NATIONAL DAM INSPECTION PROGRAM

FEBRUARY 1980 U.S. Army Corps of Engineers  
New England District  
Email: Library@nae02.usace.army.mil

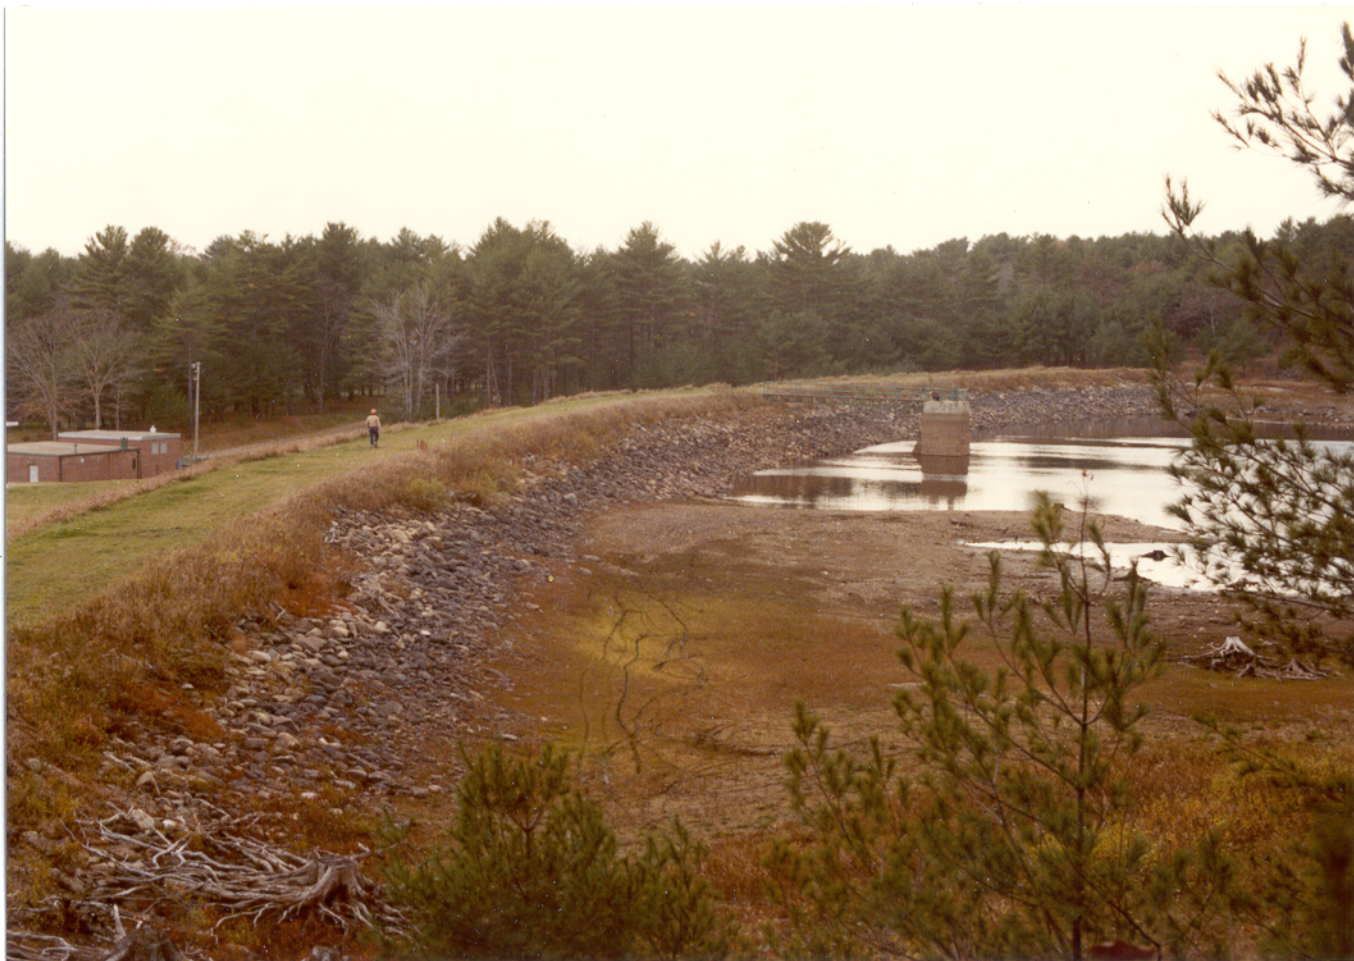
1. Overview of Boulter Dam showing upstream side from left abutment

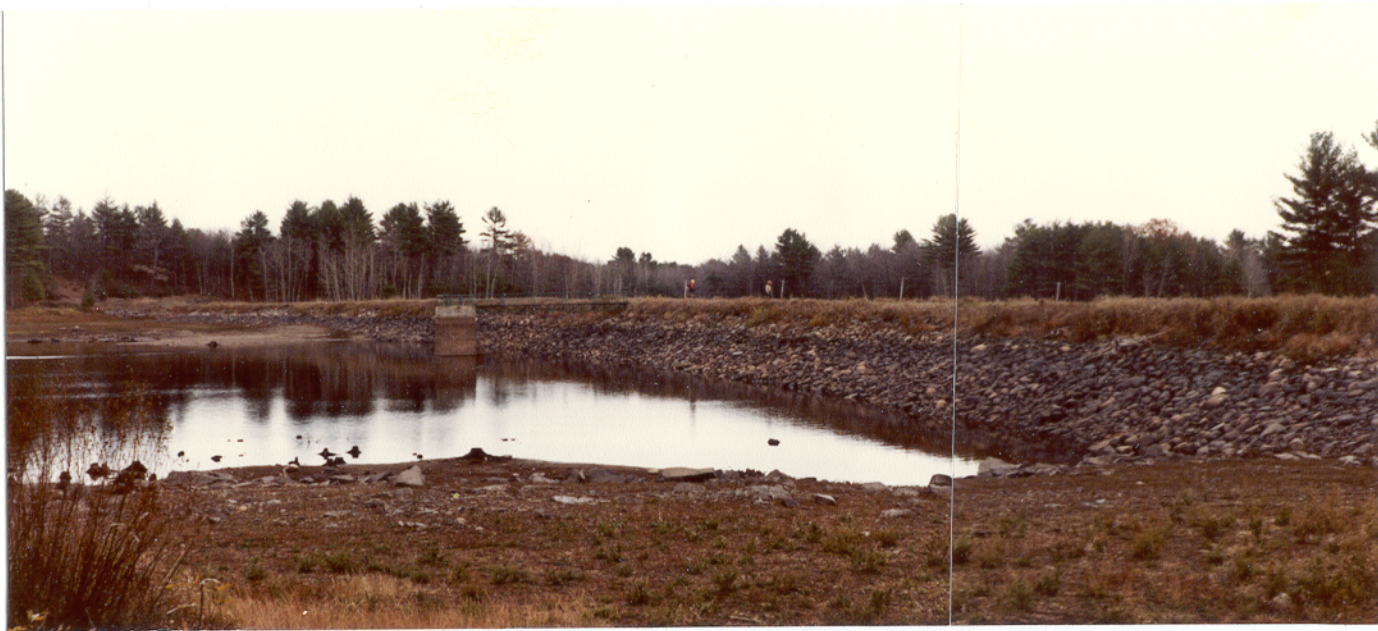
2. Overview of Boulter Dam showing upstream side from right abutment

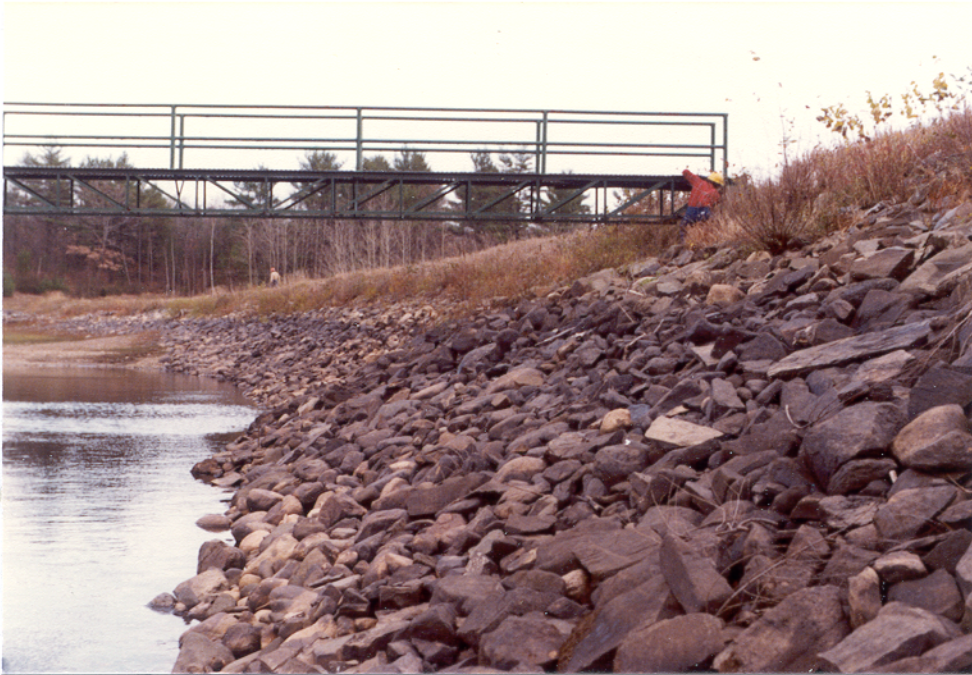
b. Dam. The earth embankment is generally in good to excellent condition. The stone riprap paving on the upstream slope consists of a layer of cobbles and boulders with some broken rock varying from 4 in. to 3 ft. in nominal size, Photo No. 2. Grass, weeds and other vegetation are growing in the riprap along the top 6 ft. of the embankment. The stone riprap beneath the service bridge appears to project out, about 1 foot, perpendicular to the slope over a distance of about 30 ft., Photo No. 3. It is probable that the embankment was constructed with this configuration.

A noticeable bulge occurs in the upstream slope beneath the service bridge. However, it is probable that the embankment was constructed with this configuration. The abutment to the service bridge has moved as described in Section 3.1c. This condition places the structural stability of the service bridge abutment in question.

3. View of riprap near service bridge

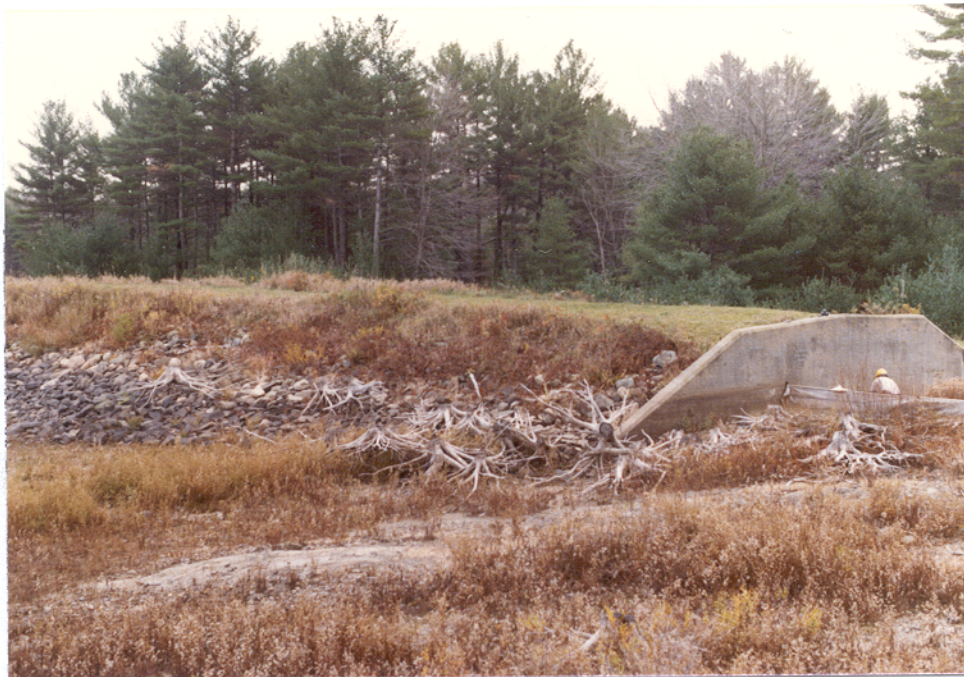
The grass and vegetation along the crest of the embankment are low and in some areas the crest has been worn bare, probably by two-wheeled or other vehicle traffic. The crest on the right side, Photo No. 4, is 6 to 12 in. lower than the adjacent concrete training wall and appears to be generally lower than the crest elevation of the dam within about 20 ft. of the wall. Overall, the vertical alignment of the embankment crest is good and the horizontal alignment is curved as designed.

4. Right end of earth embankment, upstream

4. Place earth fill on the right end of the embankment adjacent to the spillway training wall to restore the embankment to intended grade.
5. Repair the spalled areas of the spillway weir and toe of the left spillway training wall.

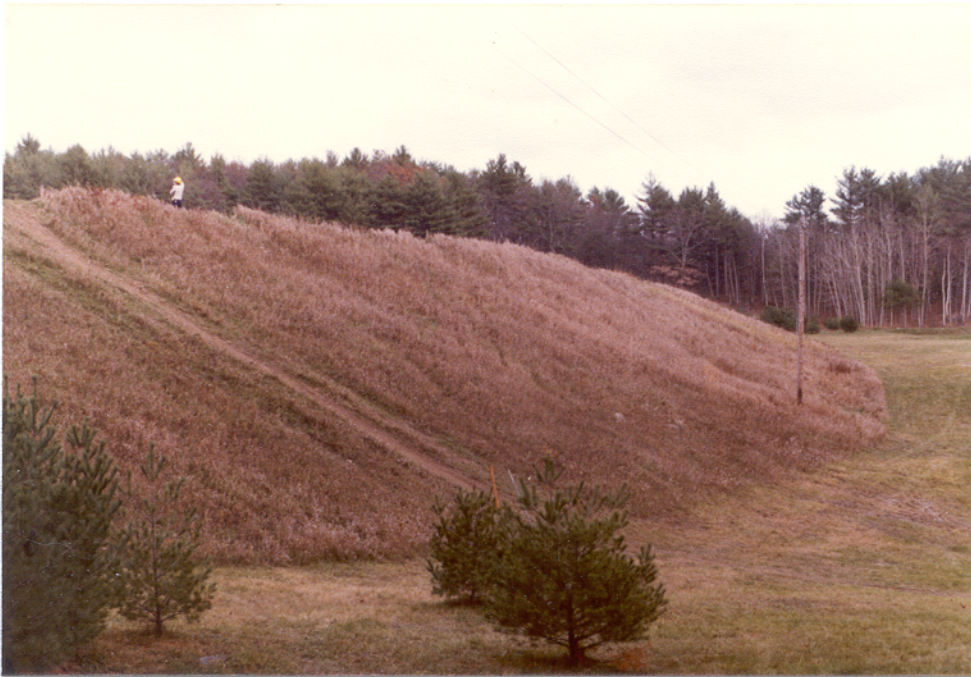
The downstream slope of the embankment is covered with tall grass and weeds as shown on Photo No. 5. No seepage or low wet areas were apparent, but the reservoir level was low the day of the visual examination, at about El. 66.5, which is approximately 8.5 ft. below the permanent spillway crest. No animal burrows were noted in the embankment; however, the thick vegetation did make the downstream slope difficult to examine. A set of 1-ft.

wide stone steps is located on the downstream slope about 100 ft. left of the intake tower service bridge, Photo No. 6. A well worn path located adjacent to the steps and another further to the right, Photo No. 5, both appear to have been made by motorbikes.

5. Downstream slope of embankment near center of dam

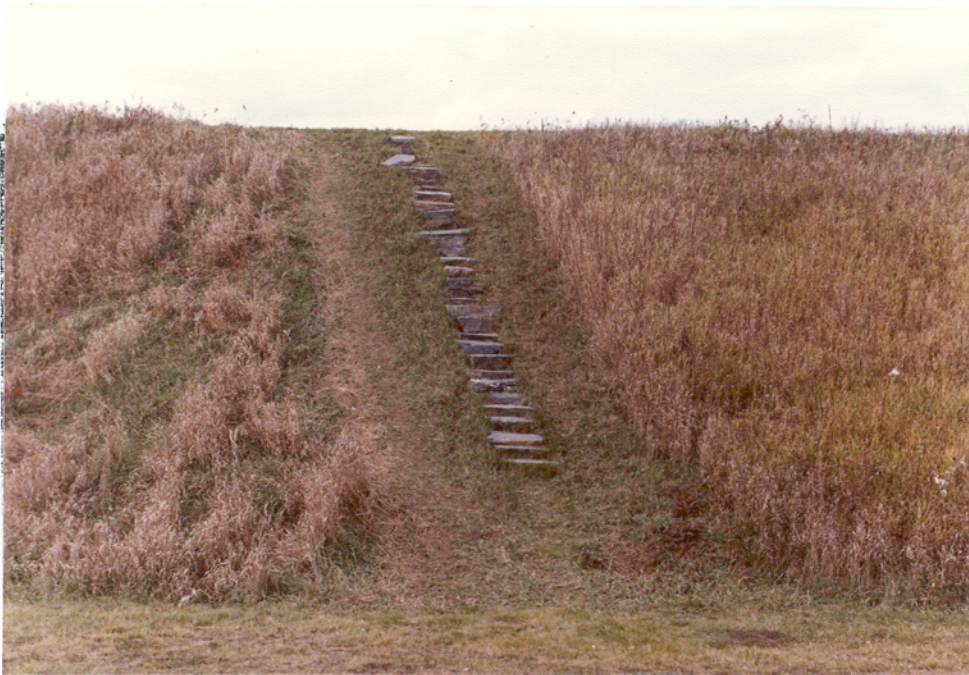
6. Stone steps on downstream slope

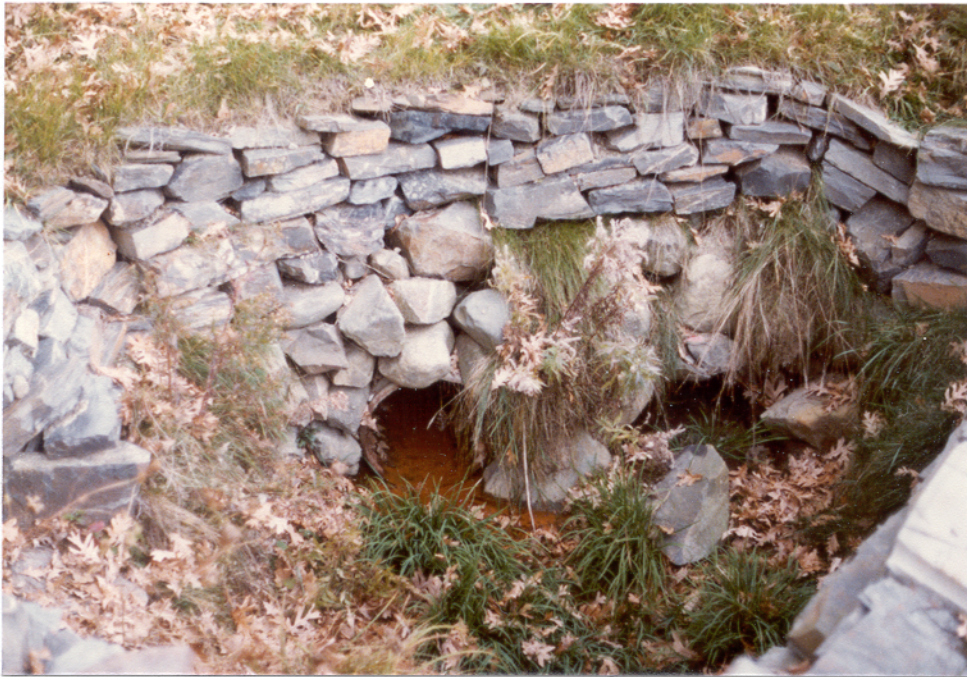
During the site examination, the location of the 6-in. diameter outlet for the internal drainage system could not be located. Subsequently, the Superintendent of the Kittery Water District stated that the internal drainage system connects to the 16-in. C.I. pipeline that serves as a reservoir drain. Several catch basins have been added to the site for surface drainage since the original construction of the facility. The 16-in. reservoir drain outlets at a 6-ft. deep broken stone-lined pit with two CMP conduits and cast iron pipes leading to it. The pit is located approximately 180 ft. from the downstream toe of the dam, Photo No. 7, and has a noticeable rust brown residue in it.

7. Stone lined drainage pit downstream of dam

6. Repair the cracked and spalled areas of the service bridge abutment; realignment inclusive.
7. Develop a system for monitoring flow out of the internal drainage system such that it may be correlated with reservoir water surface elevation.

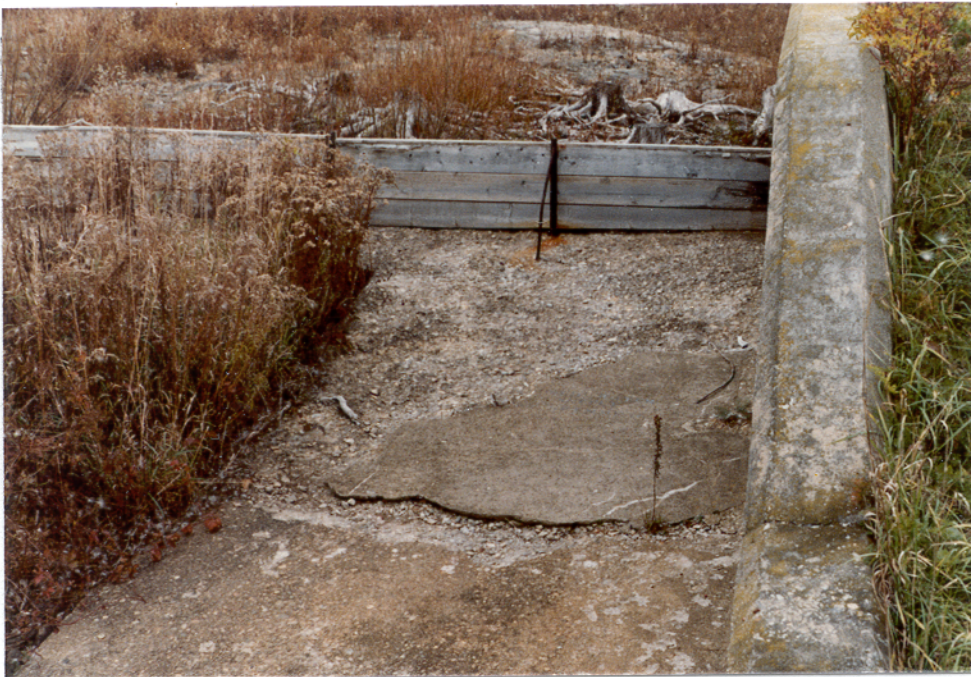
c. Appurtenant Structures. The spillway is in generally good condition. The concrete portion of the weir has spalled, Photo No. 8, as has the concrete slab adjacent to the toe of the left training wall.

8. Flashboards, training wall and spillway weir with spalling concrete

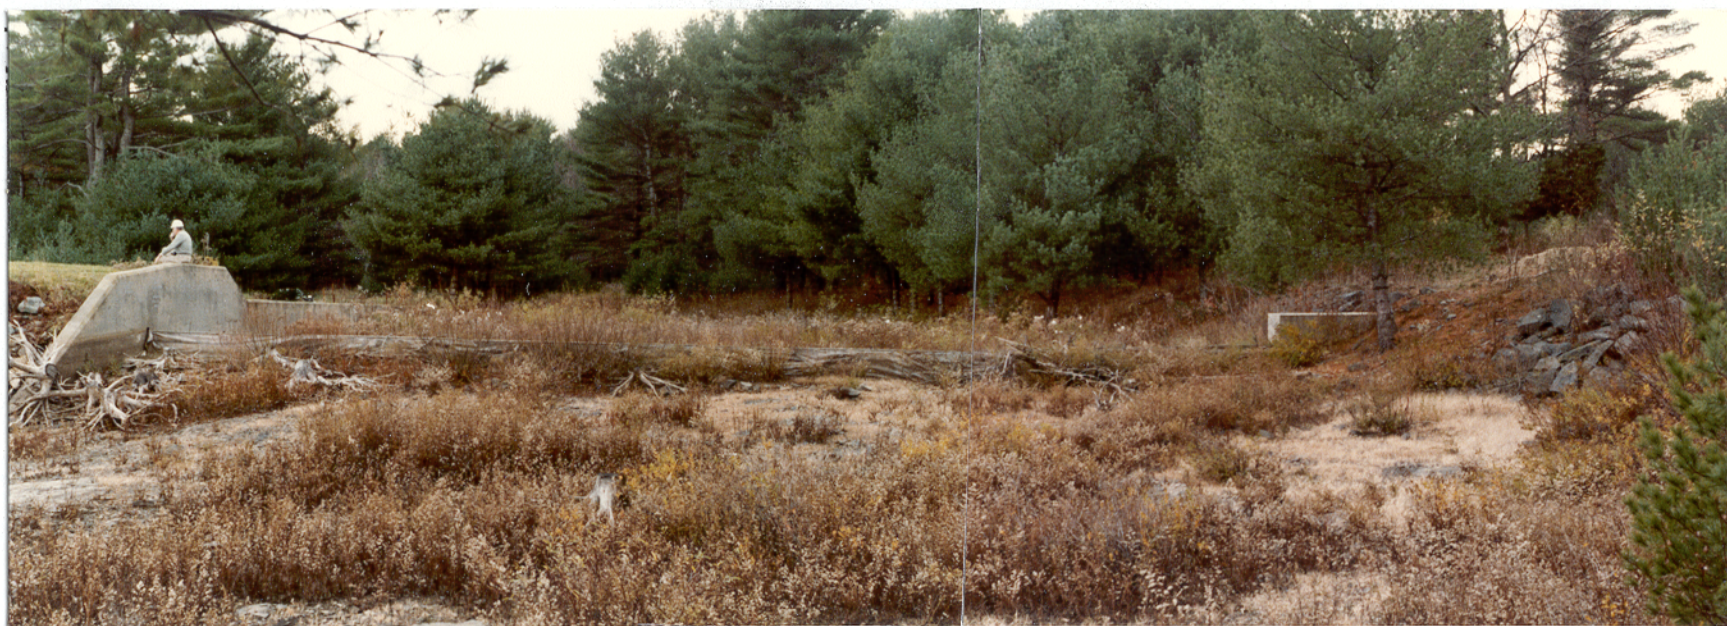
9. Spillway approach looking downstream

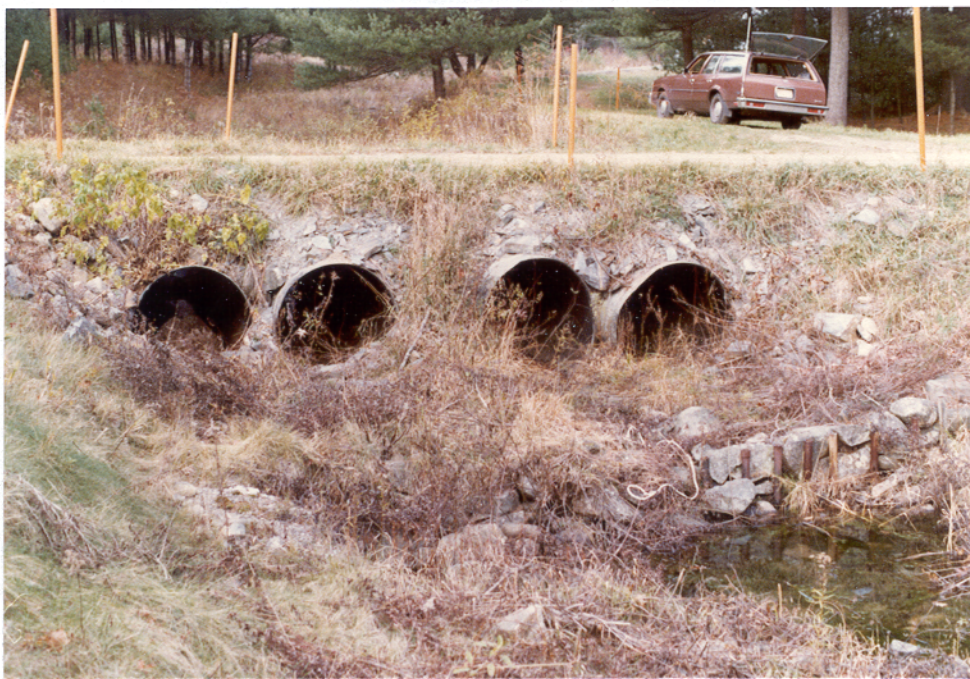
Approximately 200 ft. downstream of the spillway there are several water-filled depressions. Water is flowing from one of the depressions at an estimated rate of less than 1 gpm. Minor seepage is also occurring in the rock further downstream. Downstream of the access roadway there are five steps constructed at about 30 ft. intervals to minimize scour and erosion of the channel. The steps are formed by a line of 2-in. diameter steel pipes driven to hold a shallow wall of broken rock, Photo No. 10.

10. Conduits under access roadway, downstream

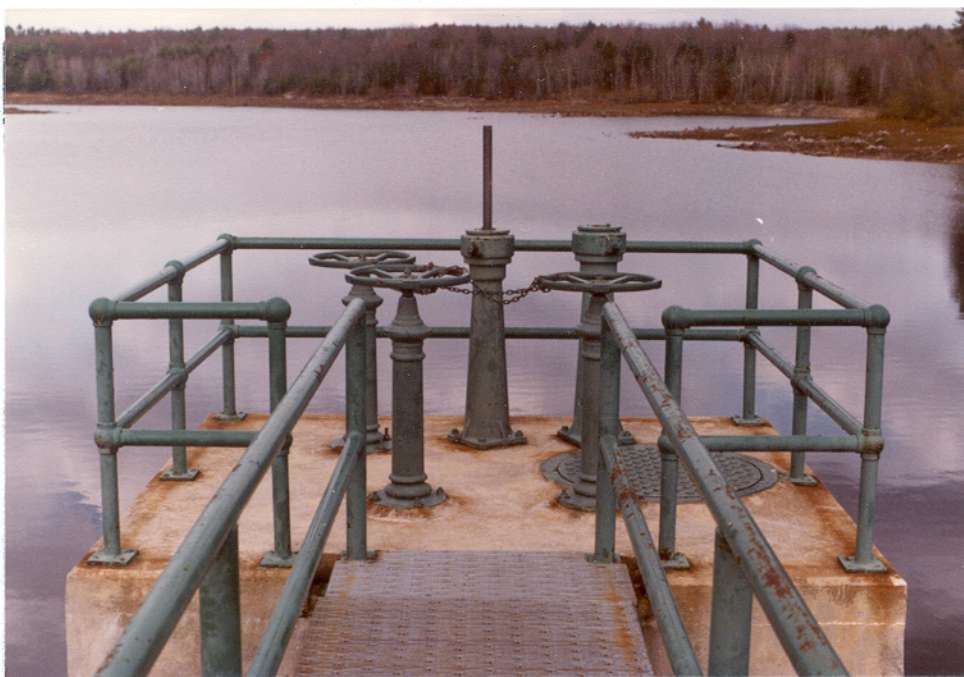
The intake tower is in good condition as shown in Photo No. 11. The operator of the dam was not present at the time of the inspection, and in turn, the service gates were not operated. A steel service bridge spans approximately 44 ft. from the dam crest to the intake tower as shown in Photo No. 12. The trusses are seated on bearings

11. Intake tower manual gate operators

9. Operate the gate mechanisms in the intake tower to insure their operability. In addition, a procedure should be established to operate the gate mechanisms periodically.
10. Prepare an operations and maintenance manual for the dam. The manual should include provisions for biennial technical inspection of the dam and round-the-clock surveillance of the dam during periods of heavy precipitation and high discharge. The procedures should delineate the routine operational procedures and maintenance work to be done on the dam to ensure safe, satisfactory operation and to minimize deterioration of the facility.
11. Develop a written emergency preparedness plan and warning system to be used in the event of impending failure of the dam or other emergency conditions. The plan should be developed in cooperation with local officials and downstream inhabitants.

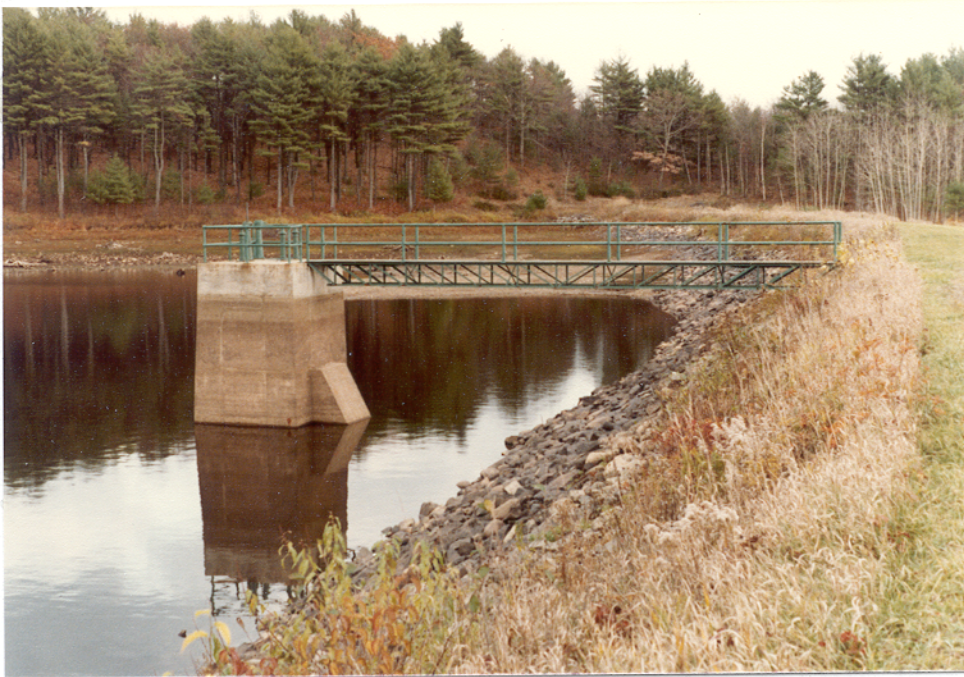
12. Intake tower and steel service bridge

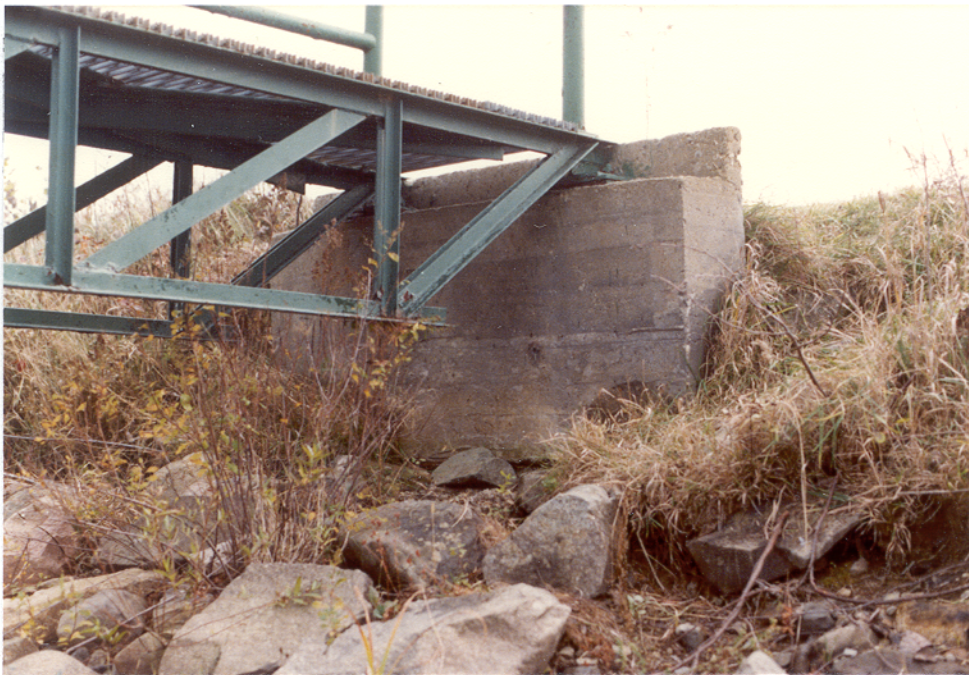
on concrete at both sides. Overall, the bridge is in good condition, though the abutment to the service bridge has moved. This displacement appears to be a downslope translation of the top of the bridge abutment either by a tilting of the abutment pier and footing or structural distress in the abutment pier. This may or may not have been caused by settlement. There is some cracking and spalling at the base of the abutment and some cracking is present at the backwall of the bridge seat, Photo No. 13.

13. Service bridge abutment
